Please check above pictures. This is VITON sleeved in NO.01, That is VITON seat with backed in No.02.

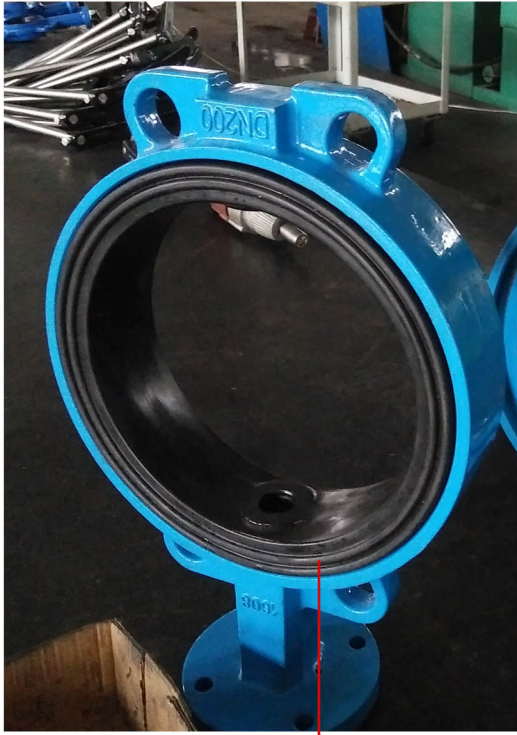
NO.01

There is no any back between body and seat, It is necessary to the machining accuracy of precision both the body and the disc, and the disc processing must be after the seat assembled on the body and then measure the dimension of the disc. It is normal to need more time than No,02, Meanwhile it also increase the processing difficulty.For these two pieces of samples, General the delivery time is under our control.But some of the accident is not what we can control Such as casting, machining, painting,etc.

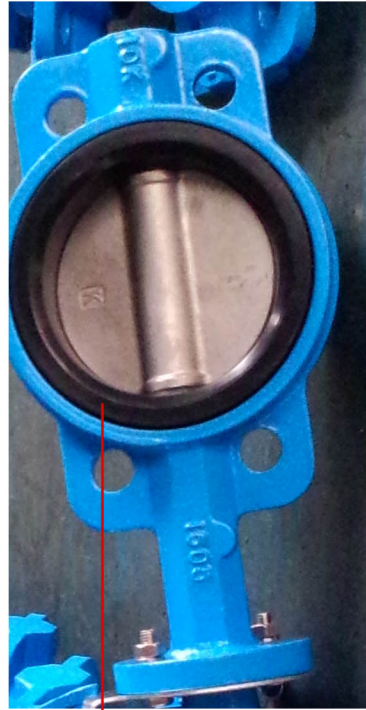
NO.02

There is with back between body and seat in No.02.The production of body, disc, seat and others processing can be simultaneously, it save more time than No.01.
